Broadway Underpass – Westlink, Belfast

Independent Report into the Flooding Incident on 16 August 2008

October 2008

Report Reference: IR1/2008

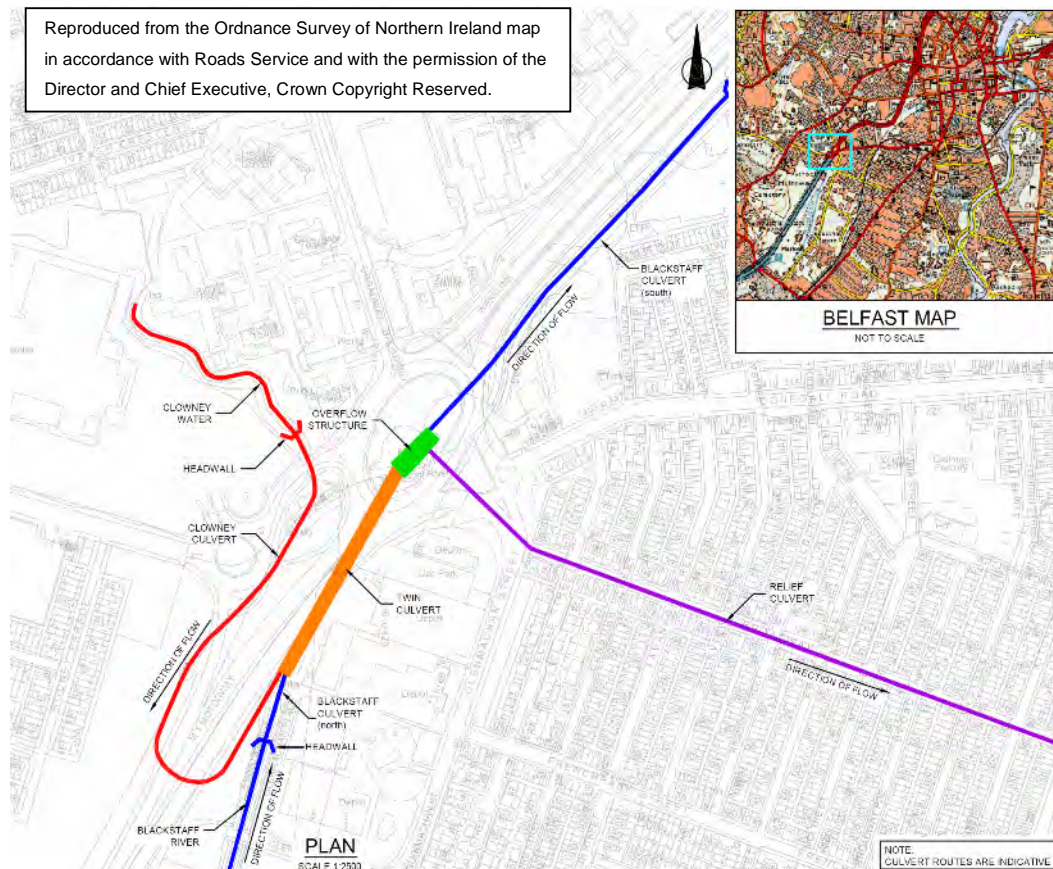
Broadway Underpass - Alternative Proposal
Clowney Water Culvert Route

3.2.8 The Clowney Water had to be accommodated within the construction works as it crossed perpendicular to the line of the Westlink and in the vicinity of the Broadway Underpass. The Clowney Water then connected into the Blackstaff River in an Overflow Structure which incorporated an overflow Relief Culvert outfalling to the River Lagan. The DBFO Co based its original design on the illustrative design, which incorporated the Clowney Water culvert within the roof slab of the new underpass. However, an Alternative Proposal was later promoted by the DBFO Co, as a DBFO Co Change, and this involved diverting the Clowney Water around the underpass, as shown in the diagram below, see also Appendix A, Fig 2. The DBFO Co Alternative Proposal was accepted in principle by the Rivers Agency prior to being implemented on site.

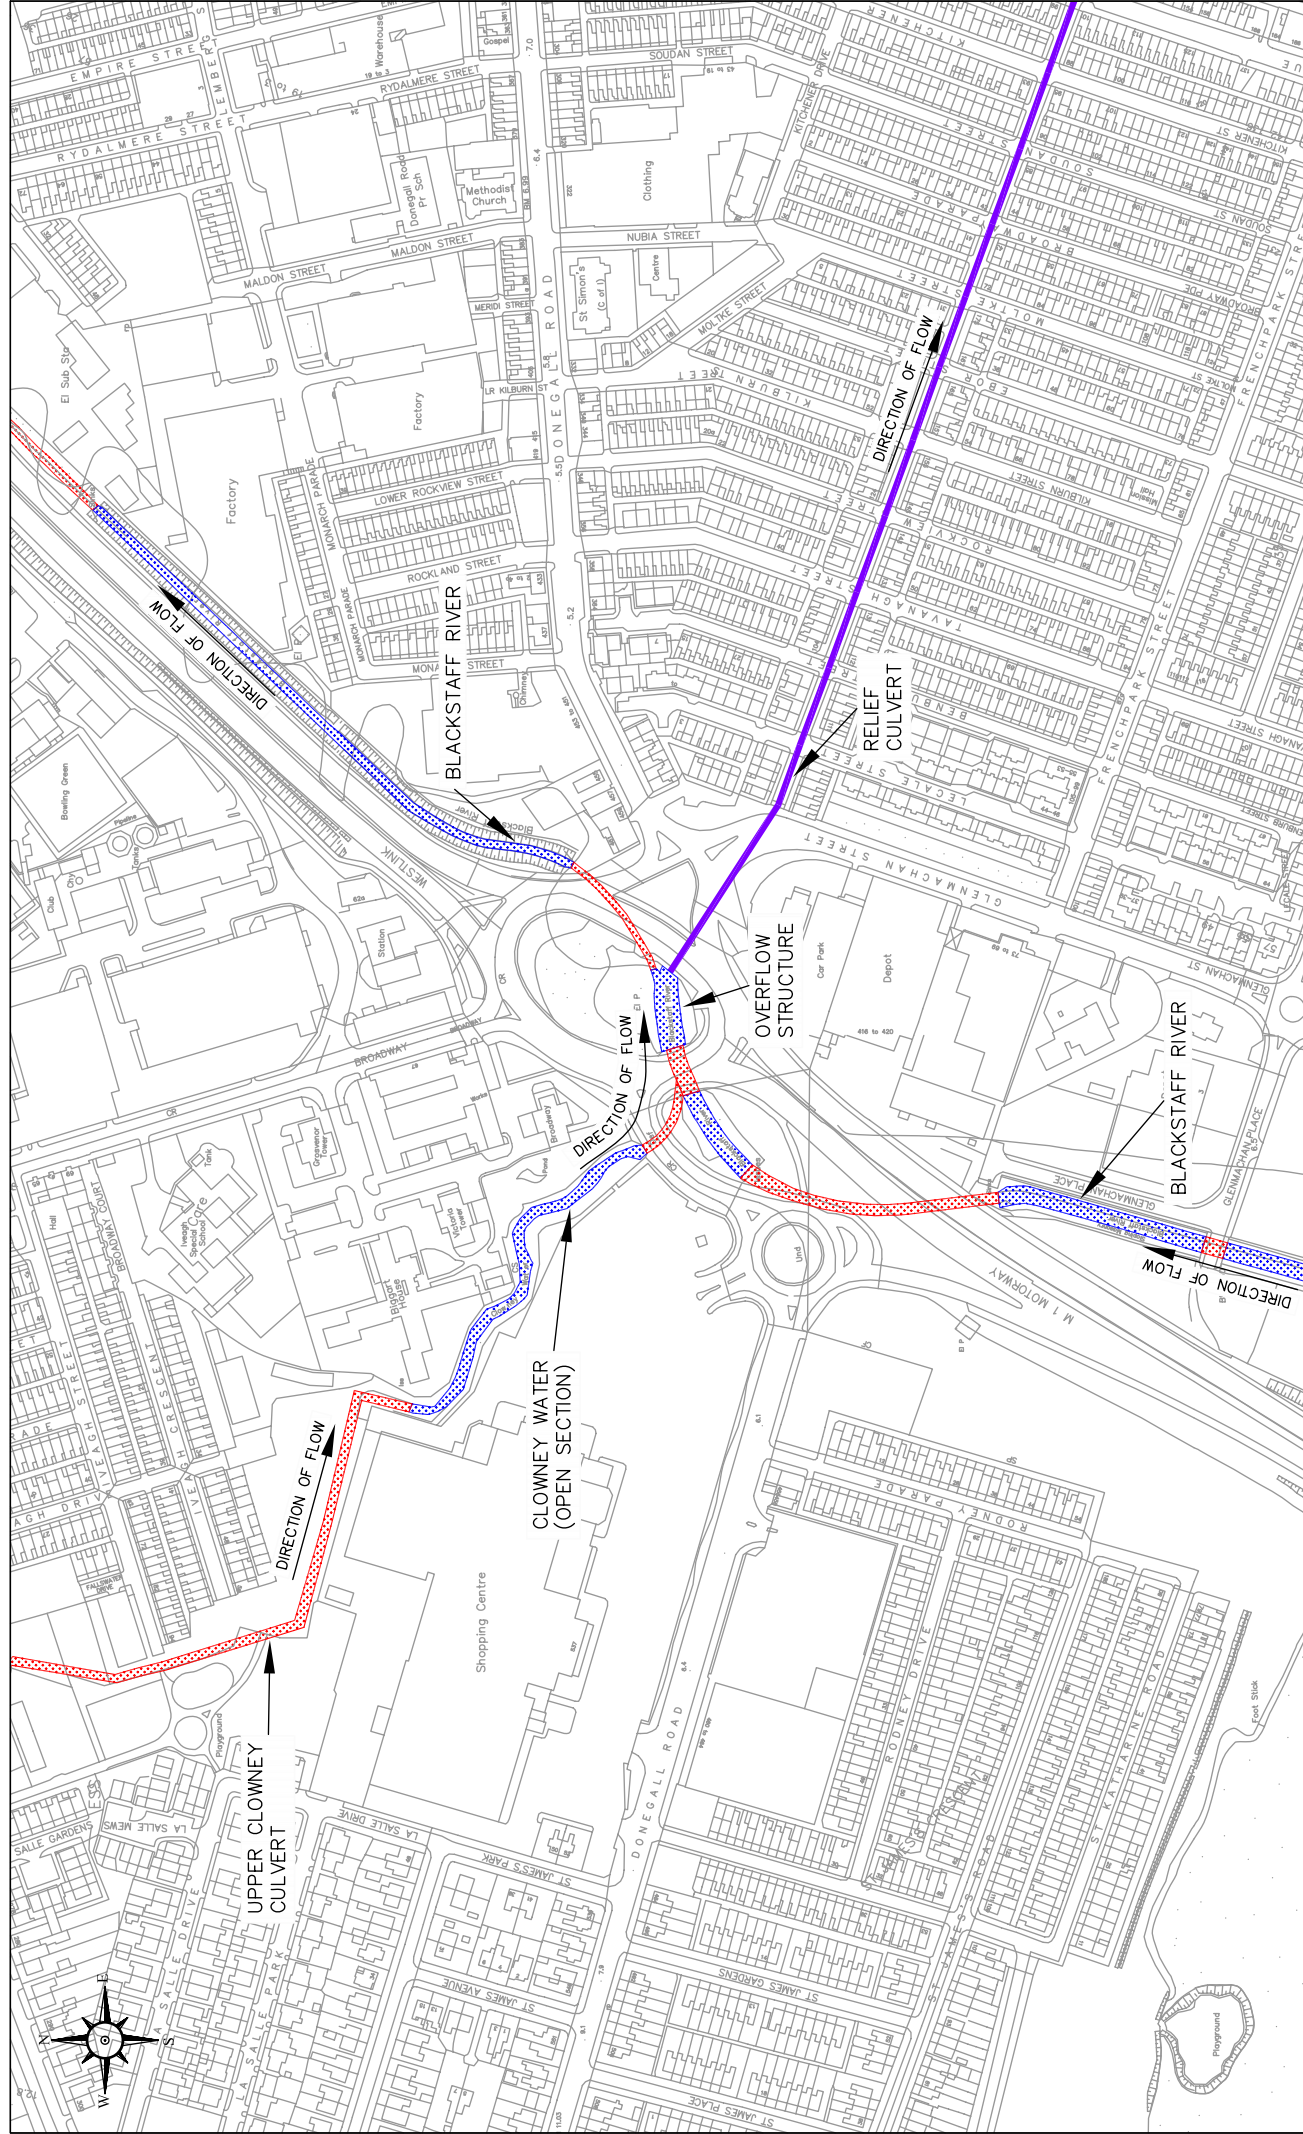
Figure 1

- 3.1.1 Broadway Underpass forms part of Scheme 1, which is part of the Roads Service DBFO Package 1 Contract. This Scheme was one of three major elements of new works involving the upgrading of the M1/Westlink, Belfast (Scheme 1), the provision of new entry slip roads at Junction 7 on the M2 (Scheme 2) and the widening of the M2 motorway between Junctions 4 and 2 (Scheme 3). The pre-existing drainage at Broadway Roundabout is shown in Appendix A, Fig 1.

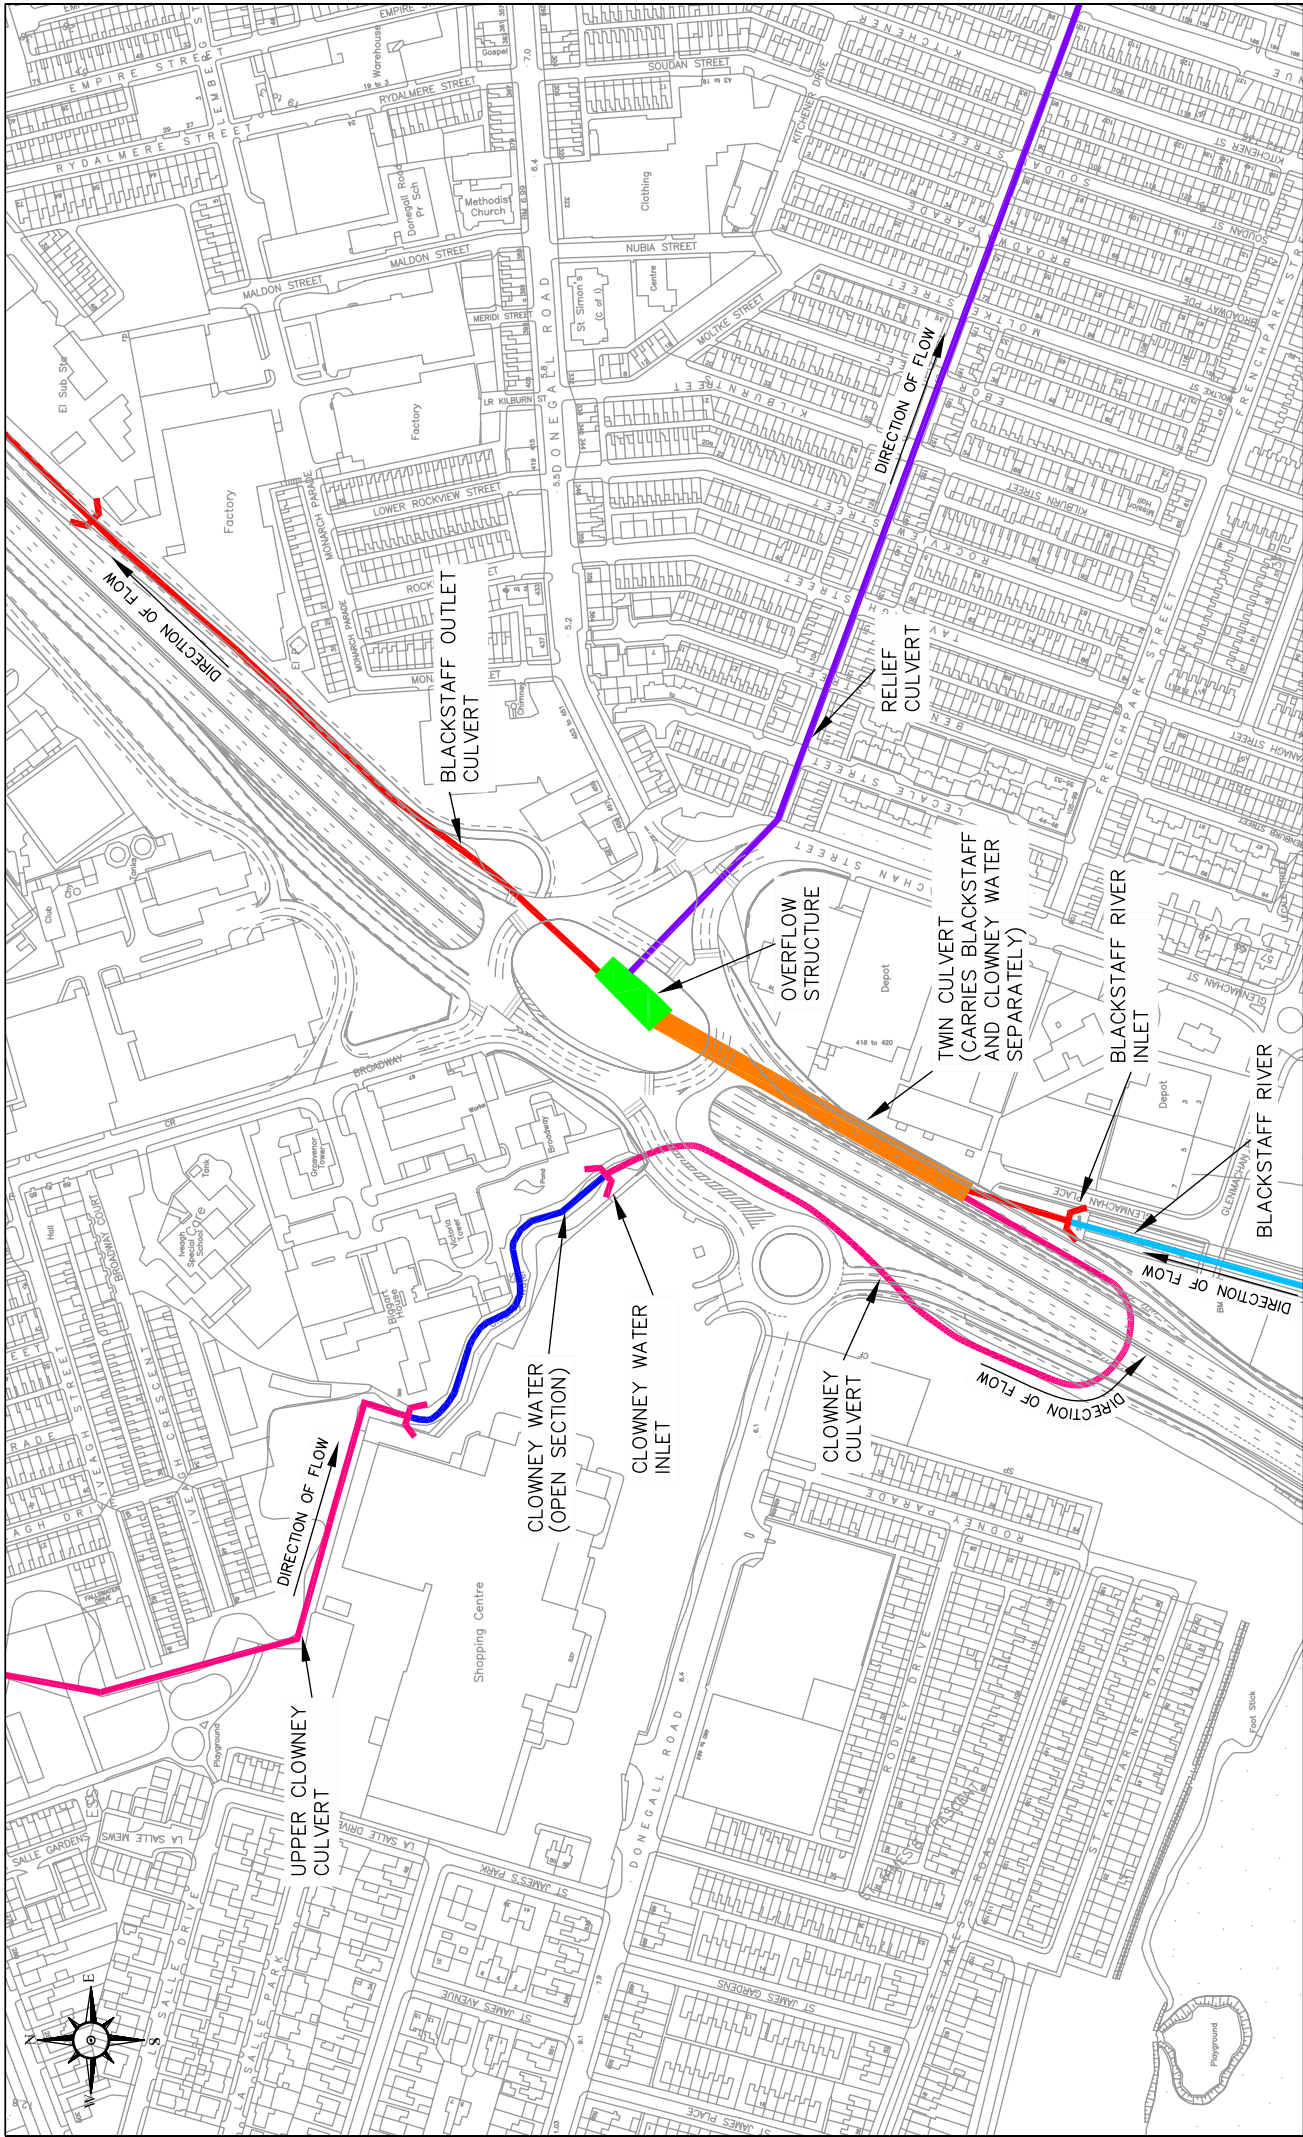
Figure 2 – Broadway Roundabout, New Drainage System

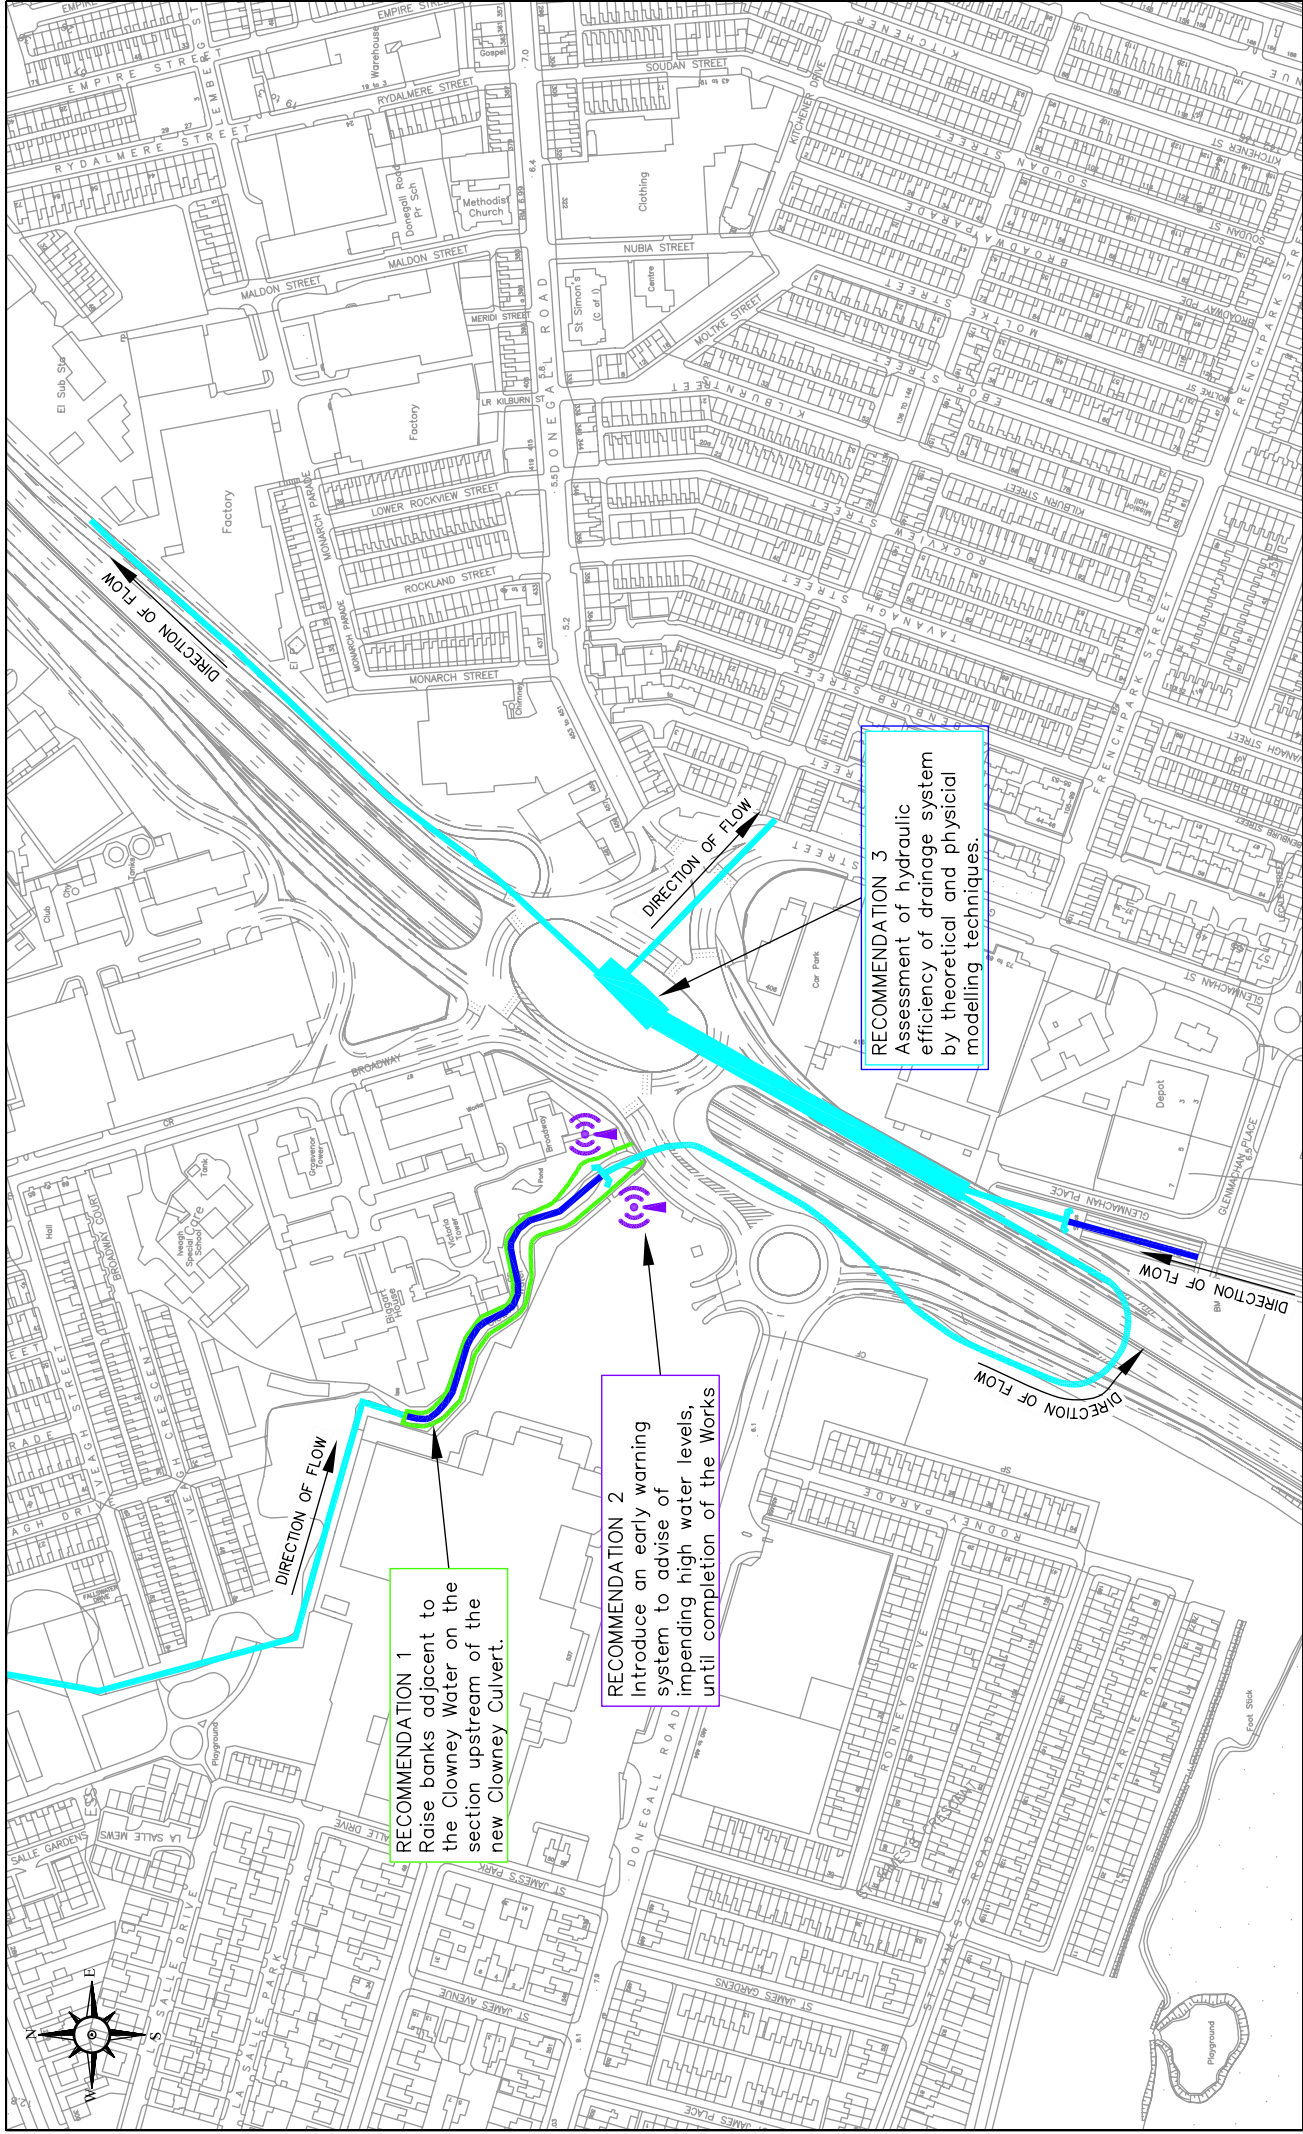
Figure 3 – Broadway Roundabout, Drainage System Recommendations

- 10.8 Whilst a blockage of the Trash Screen has probably been a contributory cause of the flooding, it is unlikely to have been the sole cause.
- 10.9 Sections of the Clowney Water banks had been increased in height to approximately 300mm above the 1 in 100 year flood level but not to the design level of plus 500mm. Whilst it is apparent that the Clowney Water would still have overtopped the raised banks, there would have been a delay in this occurrence if these earthworks had been completed.

- 11.1 Implement Mitigation Measure 5, see Appendix A, Fig 3, Recommendation 1. The DBFO Co should, at the earliest opportunity, complete the works to raise the banks adjacent to the Clowney Water on the section upstream of the new Clowney Culvert to 500mm above the 1 in 100 year designed flood level.

- 11.2 Implement Mitigation Measure 1, see Appendix A, Fig 3, Recommendation 2. The DBFO Co should develop enhanced procedures to include more regular inspections on the Clowney Water Trash Screen and introduce an early warning system to advise of impending high water levels to ensure the safety of the public, until completion of the Works. Consideration should be given to the continuation of these procedures by a responsible party after completion of the Works.

- 11.3 Implement Mitigation Measure 2, see Appendix A, Fig 3, Recommendation 3. An assessment of the hydraulic efficiency of the drainage system is required to determine tailwater levels at the Overflow Structure and the water levels in the upstream section of Clowney Water. This should be undertaken by adopting a theoretical approach supported by physical modelling techniques, using a physical model which will determine the flow patterns within the Overflow Structure and the effect that the penstock has on these patterns at alternative positions. It will also determine the significance of a Trash Screen blockage against various flow rates.

RECOMMENDATION 1
 Raise banks adjacent to the Clowney Water on the section upstream of the new Clowney Culvert.

RECOMMENDATION 2
 Introduce an early warning system to advise of impending high water levels, until completion of the Works

RECOMMENDATION 3
 Assessment of hydraulic efficiency of drainage system by theoretical and physical modelling techniques.
